## Inspection instructions for Distelclimbers with comfort straps

Occasionally, errors occurred in the assembly of the 25 mm band underneath the climbing gaff in the last series of our production. We kindly ask you to check your climbers with comfort straps.

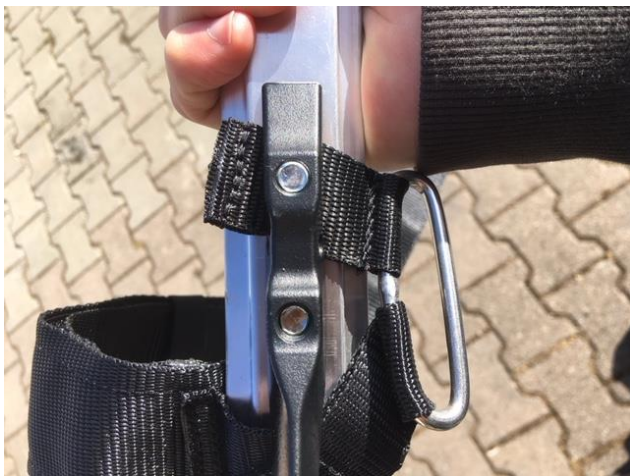
Figure 1

In the case of incorrectly mounted climbing gaffs, the 25 mm band sits obliquely or slightly obliquely underneath the climbing gaff (Figure 1) and thus prevents a plane application of the gaff to the shaft. This incorrect mounting may reduce the life of the shaft and/or screws. Please check that the tape is exactly right-angled under the gaff and that there is no gap between the gaff and the shaft (Figure 2).

First loosen both screws of the gaff slightly by 1/4 to 1/2 turn. Use a Torx wrench of size 45 to position the 25 mm tape underneath the gaff so that it forms a right angle to the gaff. Then retighten the screws in the sequence above and below. Make sure that the 25 mm band is correctly positioned in the recess of the gaff. Also make sure that the lower band is not trapped underneath the mandrel and the inner band is not trapped under the countersunk head of the lower screw. If available, use a torque wrench with a setting of 30 Nm for final assembly.

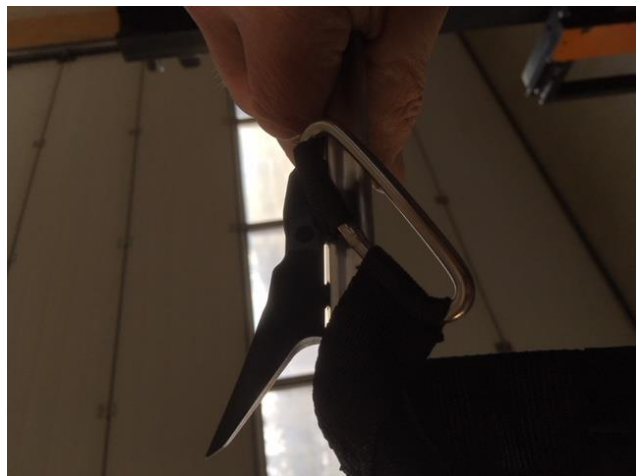
Figure 2

**If the tape is correctly mounted under the mandrel, you don't need to do anything.**
